***GEOFOAM FILL
PERFORMANCE
MONITORING***

Geofoam Fill Performance Monitoring

Interstate 15 Reconstruction Project

Salt Lake City, Utah

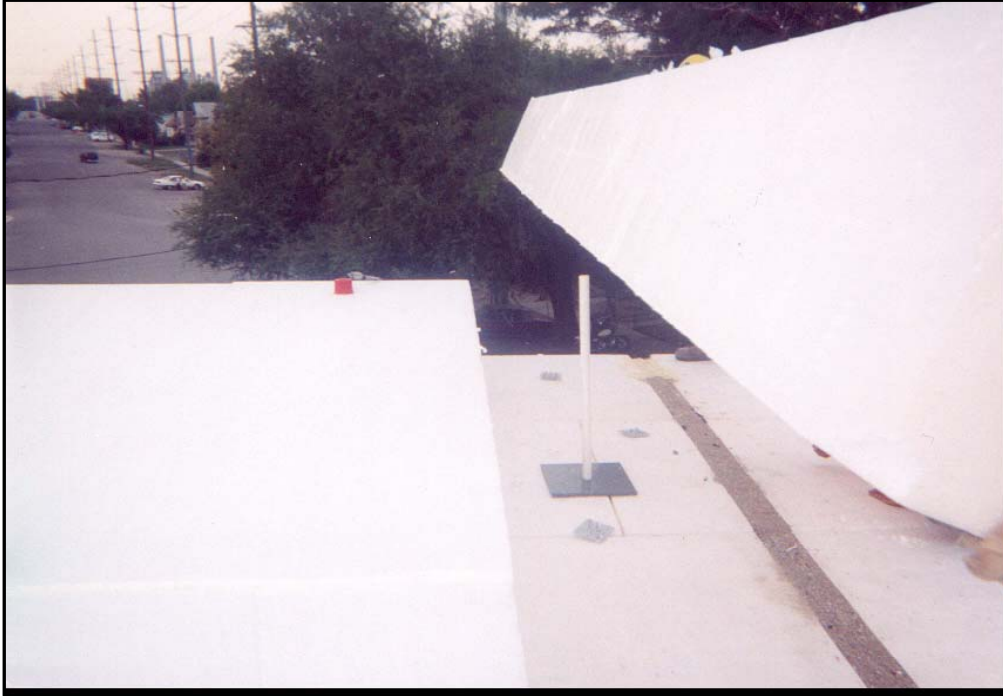
Figure 9 – Placement of geofoam block over a riser pipe and magnet plate adjacent to the sand-filled trench and the top horizontal inclinometer.

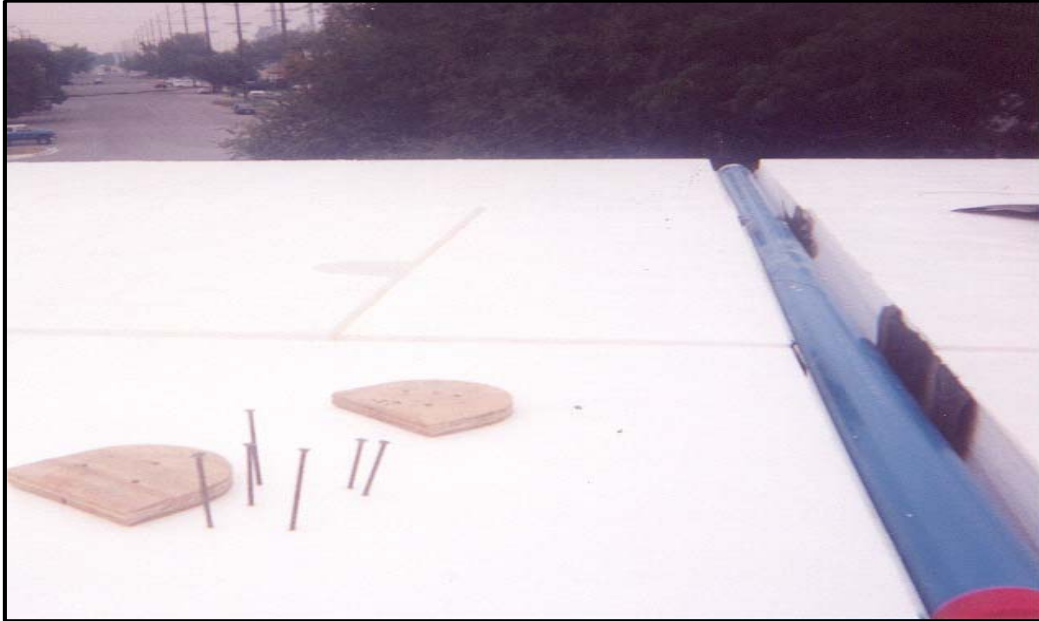
Figure 11 – Completed trench for top inclinometer casing, with plywood forms in foreground. Note the geotextile fabric to retain sand backfill across geofoam block joints.
